Inspection Report

Property Address:
9876 Property Blvd.
Niles, IL 60714

RCM Home Inspections, LLC

Date: 5/6/2005	Time: 09:30 AM	Report ID: Sample 1
Property: 9876 Property Blvd. Niles, IL 60714	Customer: Mr. John Sample Mrs. Jane Sample	Real Estate Professional: John Smith ABC Realty

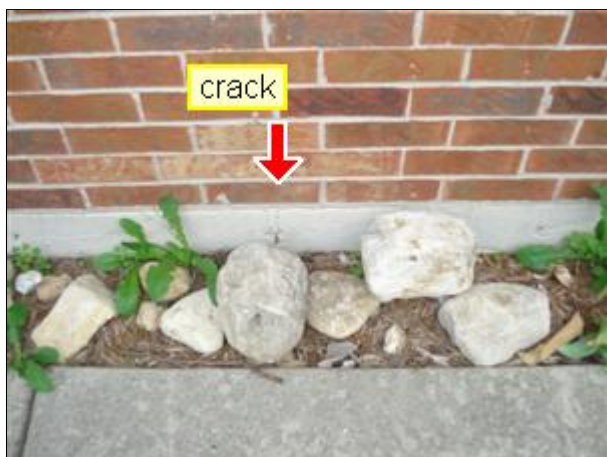
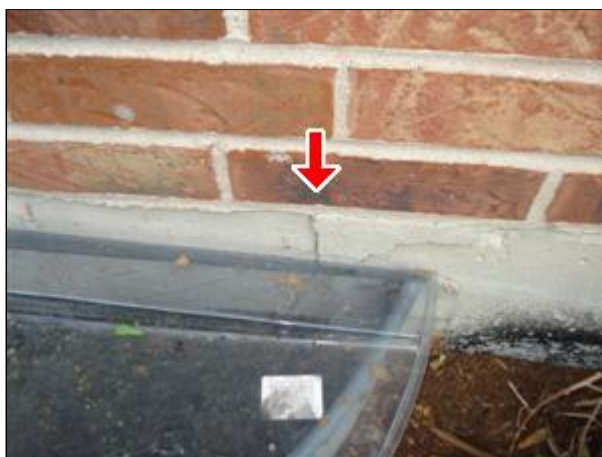
Foundation is older poured concrete with several signs of vertical cracking (Picture 1 & 2 are examples) around perimeter of house and by window wells, probably due to settlement. These cracks appear to have been professionally repaired from inside. No signs of efflorescence or wicking to brick. The some corners of the foundation (Picture 3 & 4 are examples) had small pieces of concrete missing

WL- Recommend that the foundation be monitored for a period of time since crack repairs were recent.

RR - Recommend that corners of foundation have sufficient tuck pointing applied by a qualified mason to insure that brick is fully supported. These areas should be monitored periodically for potential displacement of brick.

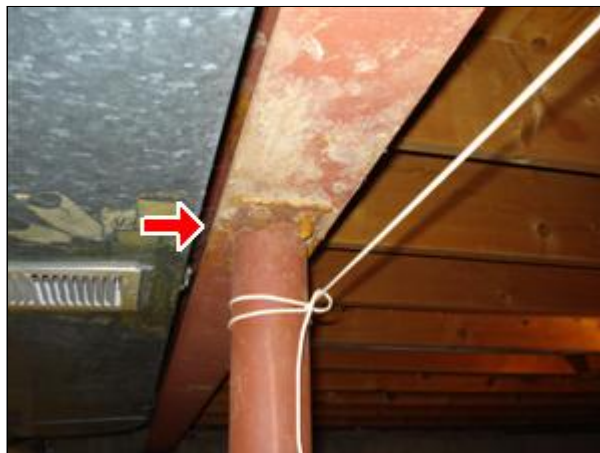
Structure is supported by a centrally running steel girder, running north to south, and supported by steel posts. The girder and post displayed signs of rust with no displacement. The posts are not secured properly to girder since bolts are missing and/or not tightened. This is a safety issue since this is the main support of structure.

SD - Recommend that the missing bolts connecting the metal supporting posts to the steel girders be replaced and all bolts be tightened.

RR - Recommend sealing posts and beams with a rust preventing paint.

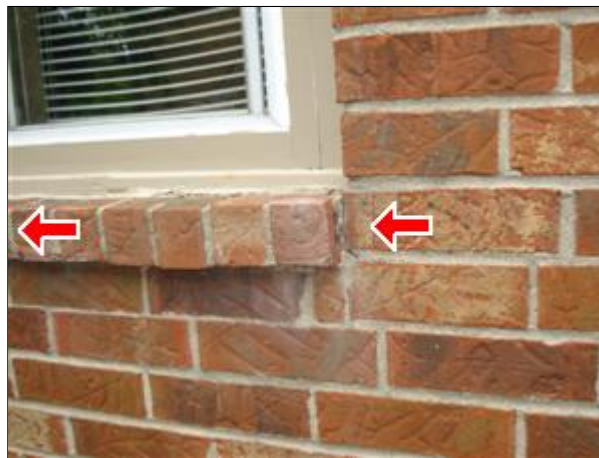
2.0 Picture 1

The brick on the north window sill trim displayed some minor missing mortar (Picture 1) consistent with the age of the house.

RR - Recommend that missing mortar in the brick sills be tuckpointed with mortar as a guard against water intrusion.

This repair can be done by a qualified brick mason.

WL - recommend annual monitoring of all brick for loose and missing mortar.

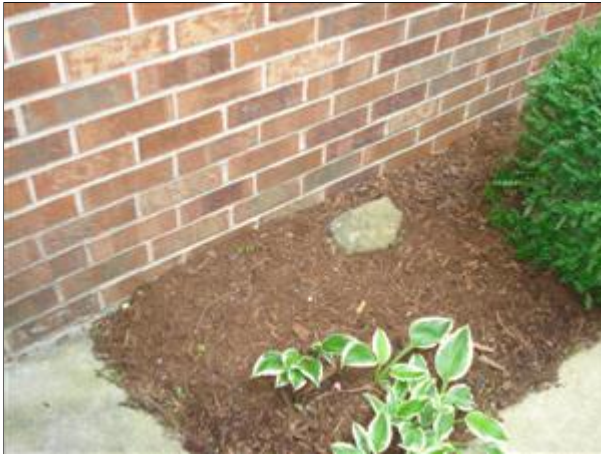
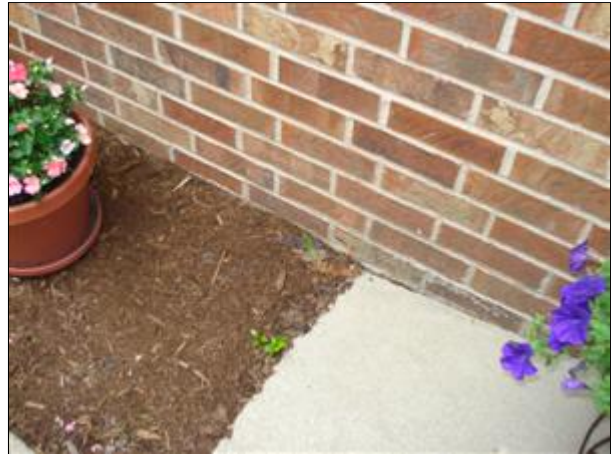
The grading around the house was somewhat high, at the front entry (Picture 1-2). It is recommended, for brick veneer houses, that 4-6" of concrete foundation be exposed above the grade level as a guard against water intrusion.

RR - Recommend lowering grade at front entry to expose 4-6" of foundation.

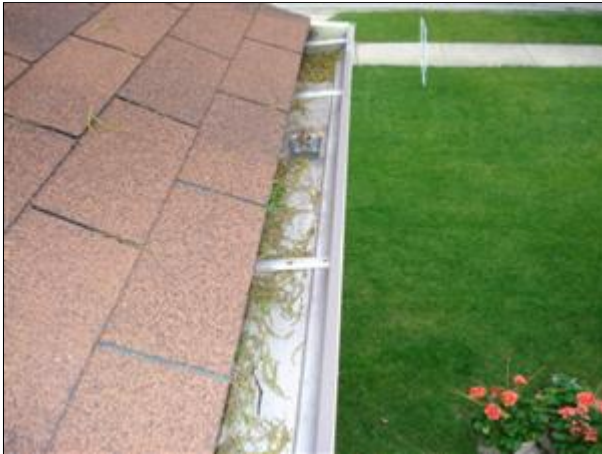
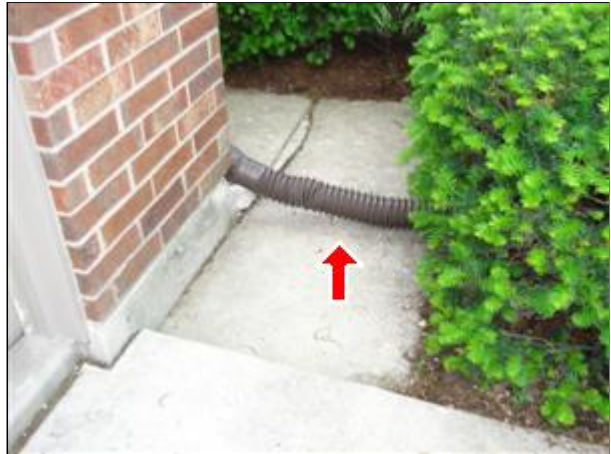
The roof is drained by means of newer metal gutters that are secured to the fascia boards by means of metal hangers (Picture 1). The spacing of the gutter supports meets the modern standard of a maximum of 18" spacing between supports. The gutters appear to be properly sloped.

Downspout extension left of garage crosses the walk causing a trip hazard.

SD - Gutter extensions should extend 6' from structure but should not cross or eject water onto walkways. This is a safety issue since the extension or freezing water can cause tripping.

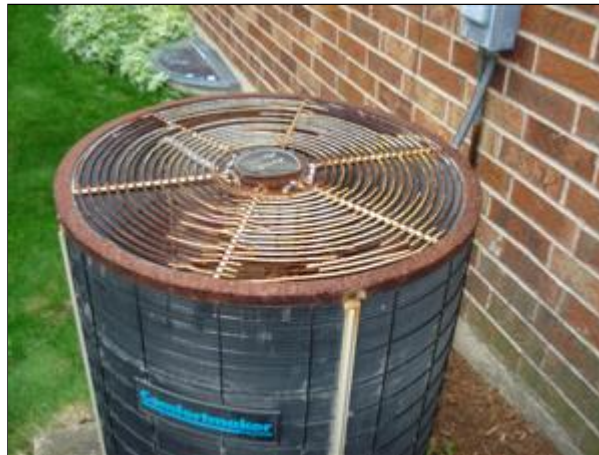
7.0 Picture 1

Air conditioner compressor was an older Comfort Maker unit. Its model and serial number and serial number could not be located to verify age or recalls. The top of unit was rusted .

WL - Recommend, as a help to maintenance, that the compressor intake vents be covered with plastic window type screening to help protect the cooling vanes from becoming clogged with dust, grass and other debris. With this screen in place, such debris can easily be wiped off and cleaning the compressor will be easier.

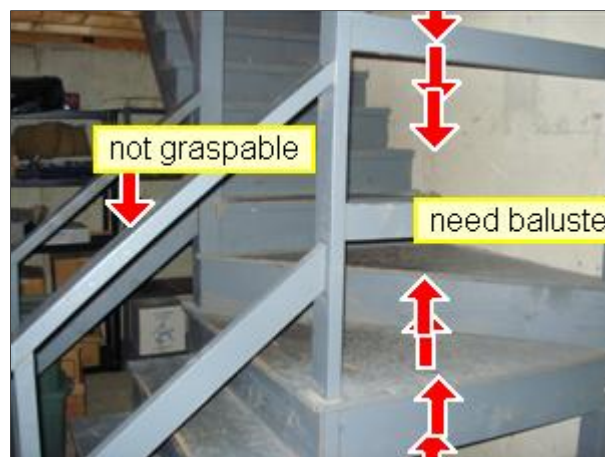
8.3 Picture 1

Basement stairs are tight and secure. The basement stairway is not equipped with balusters. 2X4 Hand rail at lower portion was not sufficiently graspable.
