Inspection Report

Property Address:
9876 Property Blvd.
Niles, IL 60714

RCM Home Inspections, LLC

Date: 5/6/2005	Time: 09:30 AM	Report ID: Sample 1
Property: 9876 Property Blvd. Niles, IL 60714	Customer: Mr. John Sample Mrs. Jane Sample	Real Estate Professional: John Smith ABC Realty

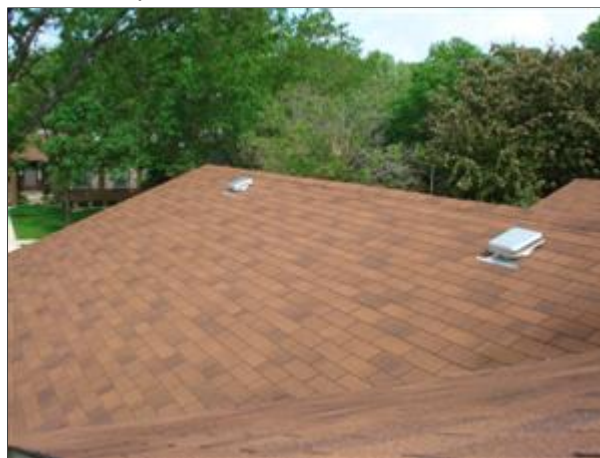
3.0 Picture 1

The roof is covered with newer asphalt impregnated fiberglass shingles in dimensional style. The roof displays no signs of missing shingles, cupping, fishmouth or displacement.

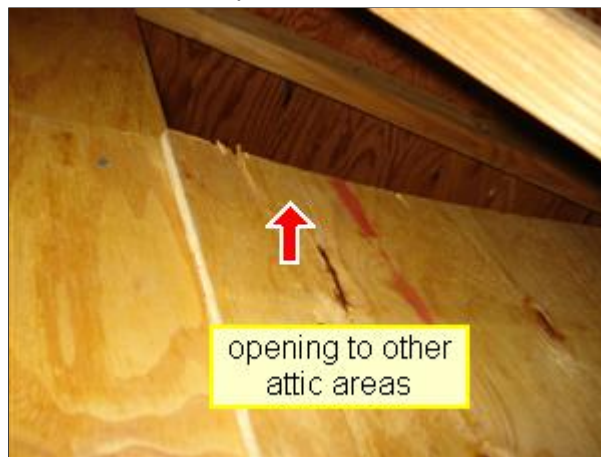
9.0 Picture 1

The attic insulation varied by three locations that were observed through three hatches that entered one common attic area. The above-the-garage attic area was partially blocked by a plywood wall (Picture 1) but had large openings to the remaining attic. The garage ceiling had drywall missing creating a direct opening to that attic. None of the hatches were insulated. There was no insulation (R0) above attached garage. There was approximately 4-6" (R18-24) of fiberglass batt/roll insulation above master bedroom. There was approximately 8-10" (R24-30) fiberglass batt/roll insulation above living, kitchen, dining rooms. Some vapor barrier was seen. The rim joists in the basement were not insulated with fiberglass batts. Wall insulation was not visible for inspection.
